Certificate of Conformance for Freight Container Mechanical Seal Testing
Seal Classification: High Security Seal

Name of Article : High Security Bolt Seals

Type : HSS-011

Test Report No. : I0520122-T01

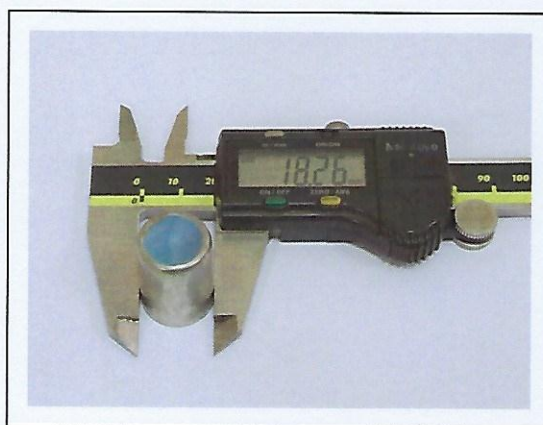
Specimen No.	Measurement (mm)		Pass/Fail
26	Pin Head	18.24	Pass
	Lock Body	18.26	Pass

The minimum diameter (or minimum widest cross-dimension) for the metal components of a bolt seal shall be 18 mm.

Lock Body

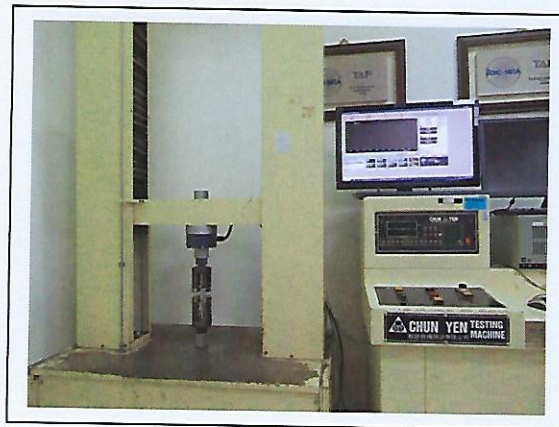
Testing Instrument : Universal Testing Machine (No.TG0103)

Universal Testing Machine

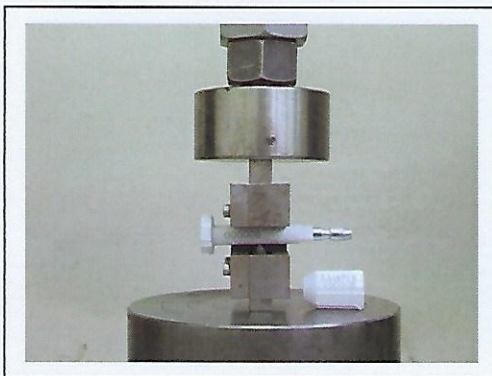
The seal was fixed in a universal testing machine to withstand cutting with shearing blades and a compressive load applied slowly until the seal is severed.

Specimen No.	Requirement Load to failure	Result kN	Seal classification
06	3.336 kN : High security seal 2.224 kN : Security seal <2.224 kN : Indicative seal	8.896	High security seal (H)
07		8.896	High security seal (H)
08		8.896	High security seal (H)
09		8.896	High security seal (H)
10		8.896	High security seal (H)

Shear Set up

SAFETY PRECAUTIONS - Do not exceed a shear force greater than 8900N(2001lbf) .If the specimen has not failed at that force, halt the test and unload the test equipment. Record a shear force of 8896N (2000 lbf).Sudden and violent rupture of the test specimen can endanger personnel, equipment and property.

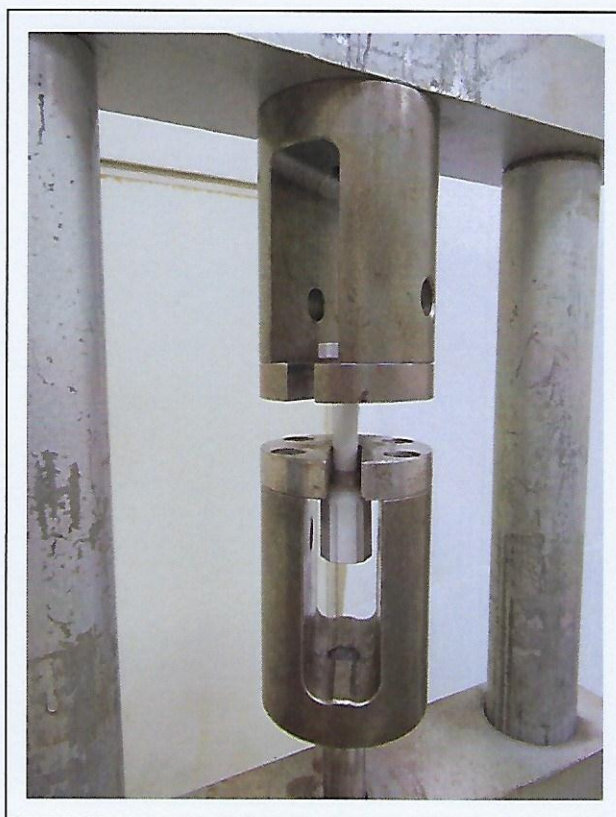
The impact test is performed at 18 degrees C and minus 27 degrees C of temperature.

The impact load is applied at the locking mechanism of the seal in the direction opposite the direction used in locking the seal.

Impact Set up

Specimen No.	Requirement	Result Joule			Seal classification
		13.56	27.12	40.68	
16	40.68J : High security seal 27.12J : Security seal <27.12J : Indicative seal 5 impacts at each load	Pass	Pass	Pass	High security seal (H)
17		Pass	Pass	Pass	High security seal (H)
18		Pass	Pass	Pass	High security seal (H)
19		Pass	Pass	Pass	High security seal (H)
20		Pass	Pass	Pass	High security seal (H)

Specimen No.	Requirement	Result Joule			Seal classification
		13.56	27.12	40.68	
21	40.68J : High security seal 27.12J : Security seal <27.12J : Indicative seal 5 impacts at each load	Pass	Pass	Pass	High security seal (H)
22		Pass	Pass	Pass	High security seal (H)
23		Pass	Pass	Pass	High security seal (H)
24		Pass	Pass	Pass	High security seal (H)
25		Pass	Pass	Pass	High security seal (H)
